NATIONAL HIGHWAY TRAFFIC SAFETY ADMINISTRATION
WASHINGTON, D C

OCCUPANT SURVIVABILITY IN LATERAL COLLISIONS VOLUME I

Contract No. DOT-HS-4-00922

January 1976

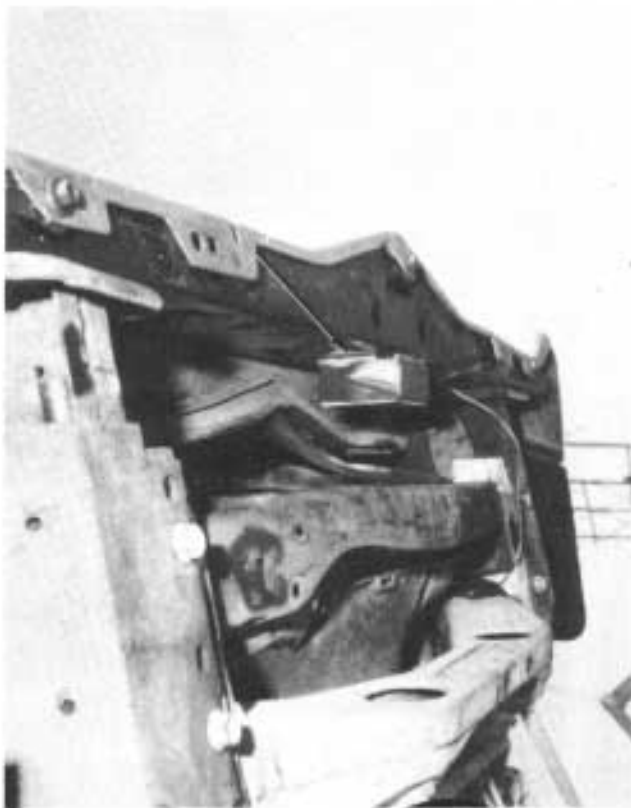
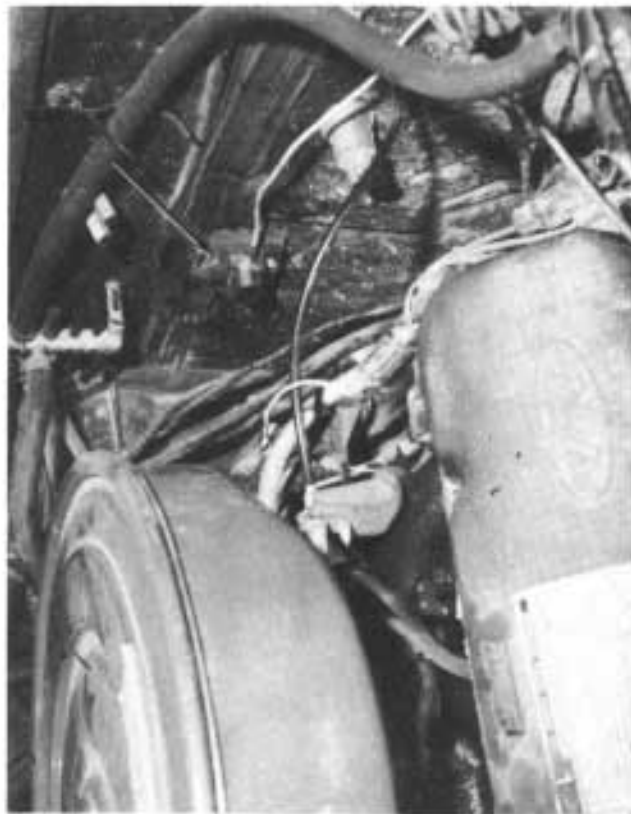
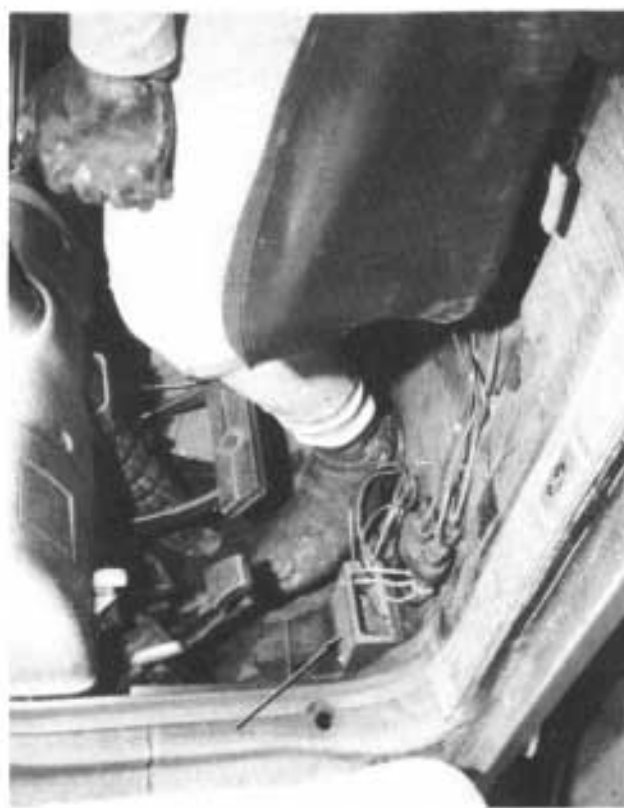
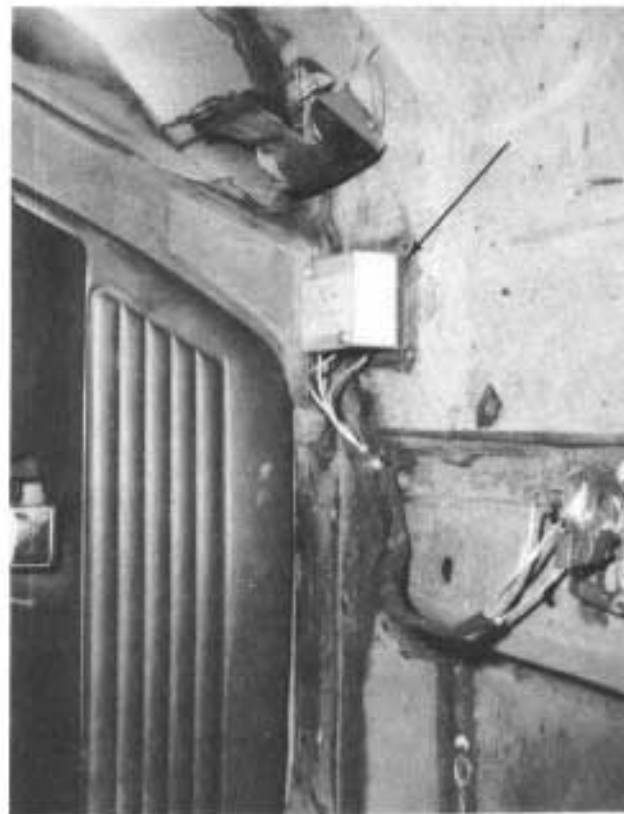
Figure 4 EXAMPLES OF ACCELEROMETER LOCATIONS

Examples of accelerometer locations are shown in Figure 4

(A) FRONT BUMPER

(B) FIREWALL

(C) LEFT FRONT FLOORPAN

(D) RIGHT REAR FLOORPAN

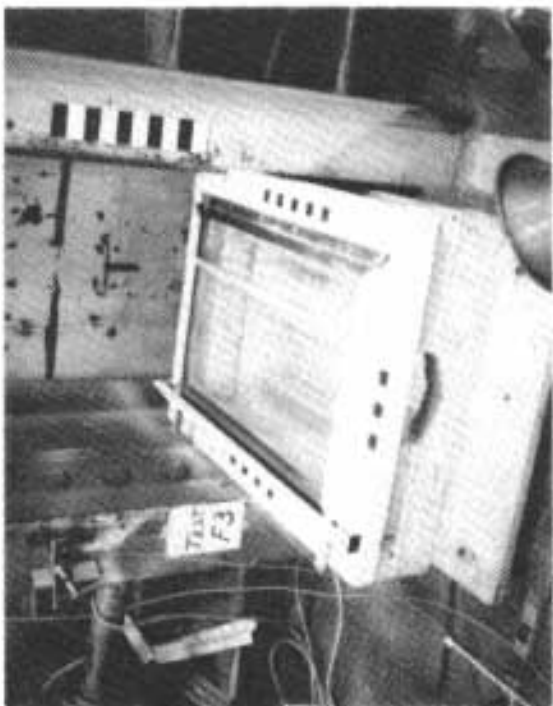
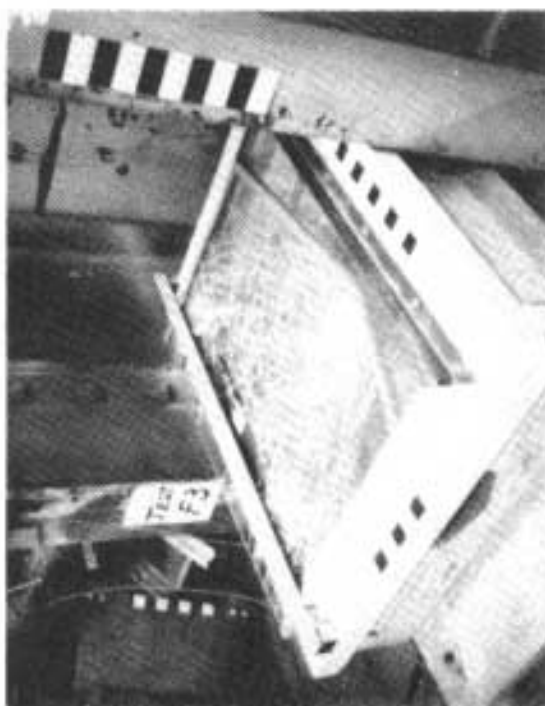
Figure 10 HEADFORM IMPACT TEST OF THREE-SIDED FRAME STRUCTURE IN A PARTIAL ROLL-DOWN CONDITION (TEST NO. 3)

Figure 8 shows the test of the four-sided frame structure, for which full retention of the glass was maintained. Figure 9 shows the test of the three-sided frame structure, which simulated a free edge corresponding to the bottom of the glass as installed in a door (normally bolted to roll-down mechanism). Full retention of the glass was also maintained with this support configuration. Figure 10 shows the test of the three-sided channel structure.

in a simulated partial roll-down configuration, in which the headform impacted approximately 3" from the channel-supported edge. Again, full retention of the glass was maintained, although the supported edge deflected approximately 3.4".

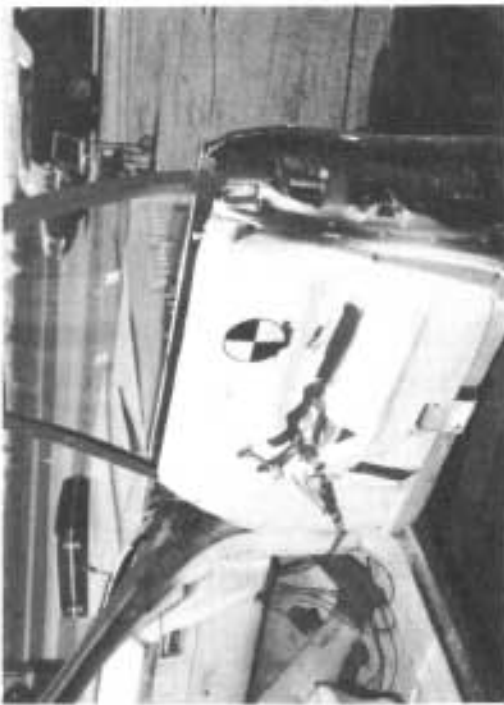
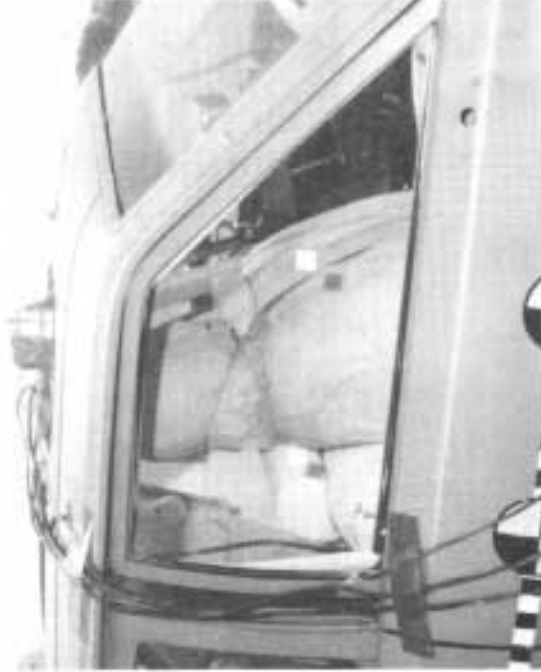
Figure 14 OPERATIONAL GLAZING INSTALLATION

Figure 14 shows a completed installation of supported, laminated glass in a modified 1973 Ford and demonstrates that the rolldown capability was preserved. A total of five modified vehicles (designated A through E) were constructed and crash tested. Each vehicle contained a front door glazing installation similar to that shown in Figure 14. The following table indicates the specific type of side glazing employed in each modified test vehicle.

(a) WINDOW CLOSED

(b) PARTIALLY OPEN

(c) WINDOW OPENED

(d) WINDOW CLOSED

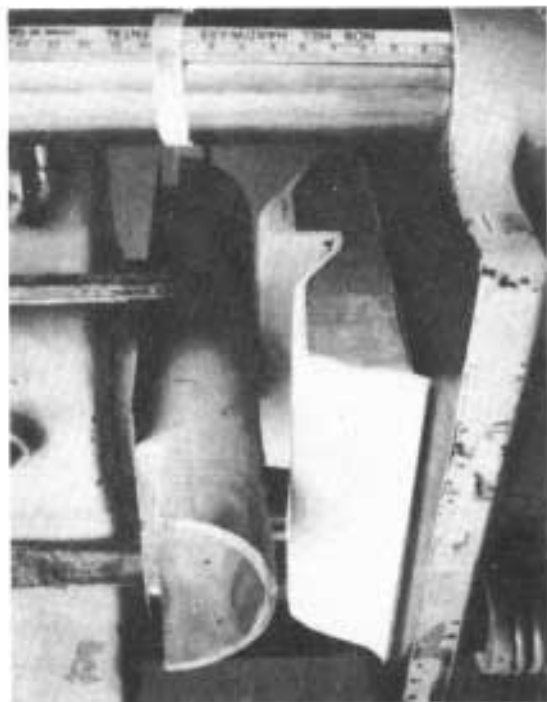
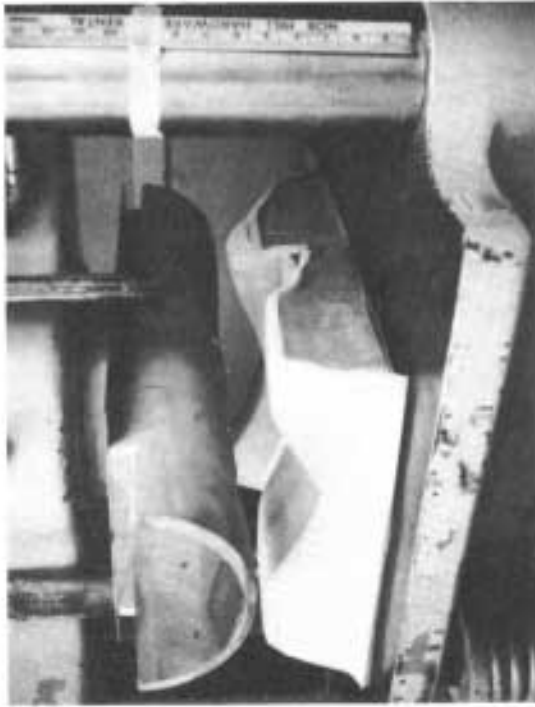
Figure 16 STATIC TEST OF CONTOURED PANEL WITH LATERAL BODY FORM (TEST NO. S3)

The materials tested statically are briefly described in Table 6. Both flat and contoured surface panels were tested. Figure 15 illustrates the tests of flat paper honeycomb (4" thickness) panels covered by 1/2" of Ensolite. The static tests of the contoured door panels fabricated from 3/8" cell and 3/4" cell paper honeycomb and Ensolite material (see Figure 25) are shown in Figures 16 and 17 for the cases of the lateral body form with and without the dummy arm, respectively. Figure 18 shows the test of the 7.5 lb/ft.³ expanded urethane material.

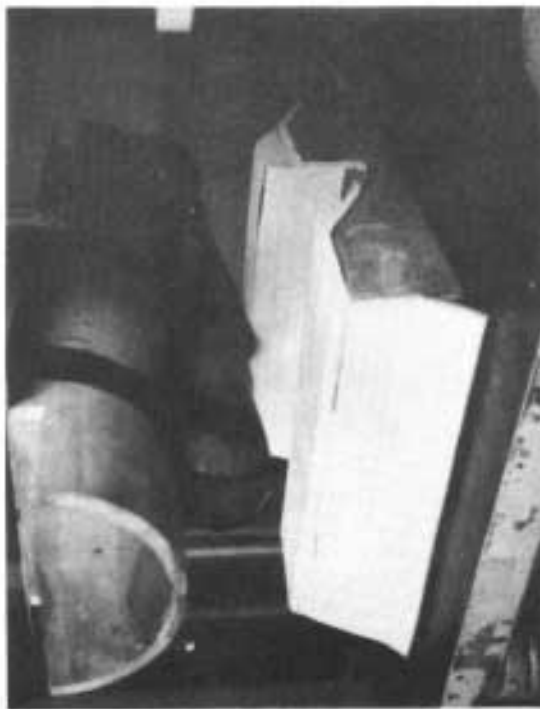
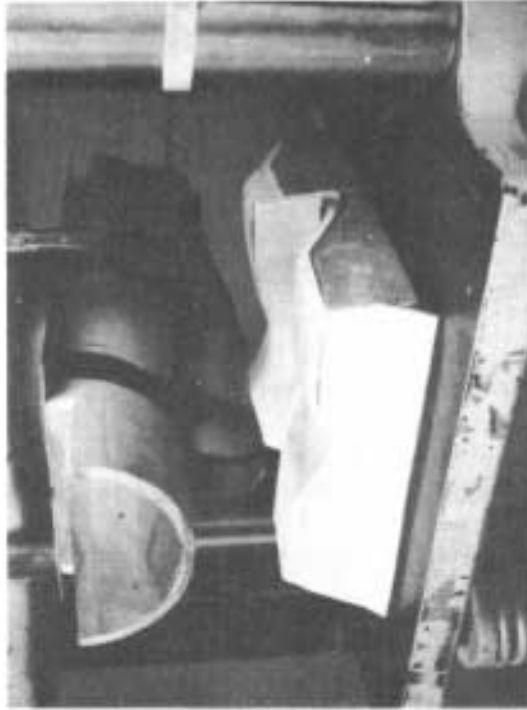
(d) AFTER
Figure 17 STATIC TEST OF CONTOURED PANEL WITH DUMMY ARM (TEST NO. S6)

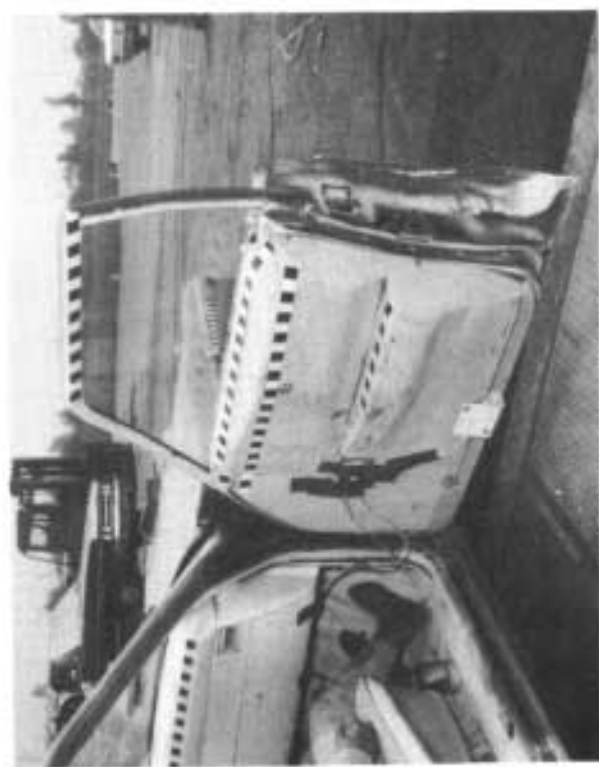
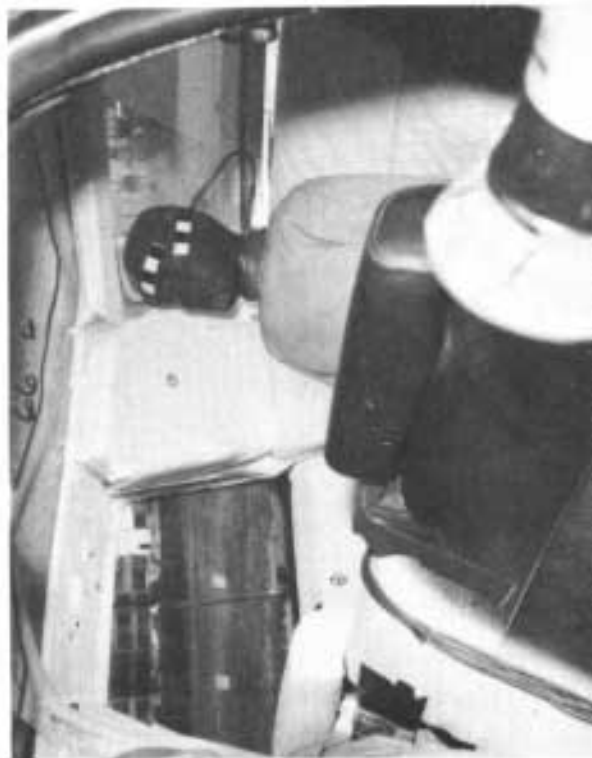
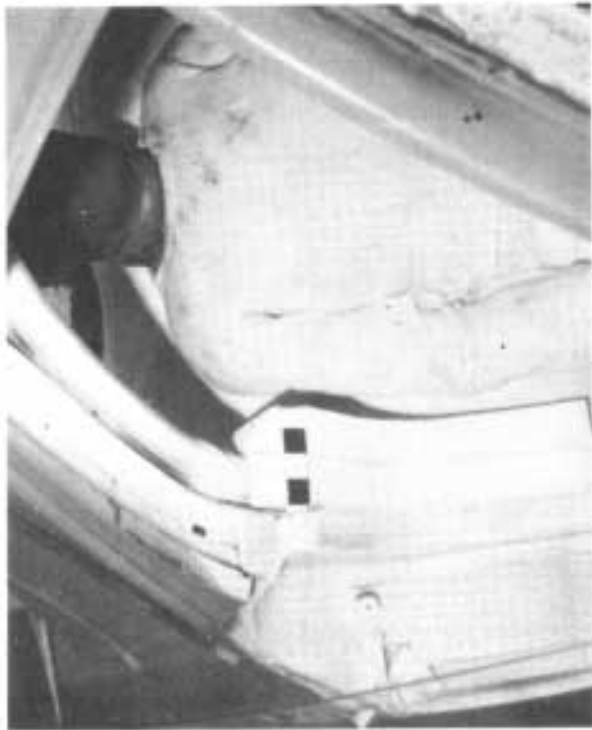
(a) FRONT DOOR PANEL

(b) REAR DOOR PANEL

(c) UPPER C-PILLAR PADDING

(d) MID C-PILLAR PADDING

Figure 26 EXAMPLES OF INTERIOR MODIFICATIONS

Figure 26 shows examples of the various interior modifications. Approximate weights of the modifications are given below.

<u>Component</u>	<u>Weight (lbs)</u>
Crushable front door panel	8.5
Crushable rear door panel	10.0
Upper C-pillar padding	2.5
Mid C-pillar padding (Impac III material)	0.5
	<u>21.5 x 2 = 43.0 (both sides)</u>

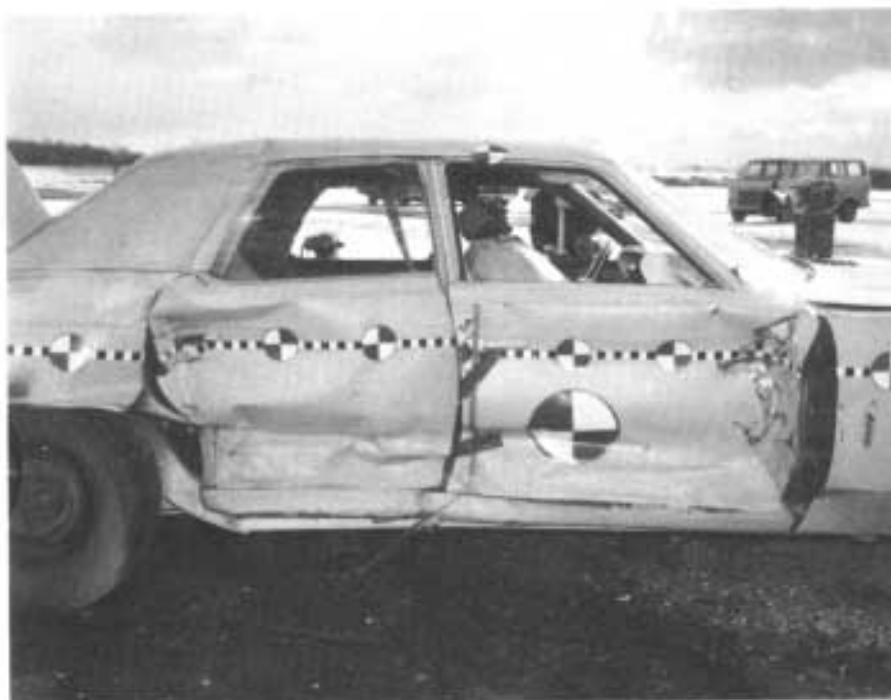
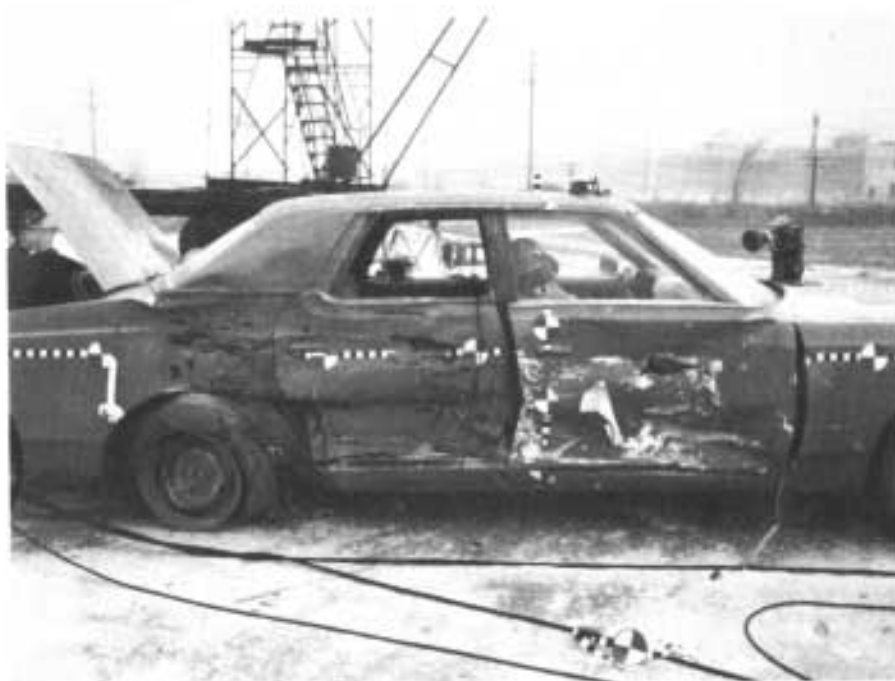
(a) ZERO TANGENTIAL VELOCITY (TEST NO. 1)

(b) 30 MPH TANGENTIAL VELOCITY (TEST NO. 2)

Figure 27 EFFECT OF TANGENTIAL VELOCITY ON VEHICLE DEFORMATION IN 30 MPH PERPENDICULAR COLLISIONS

Figure 27 compares the vehicle deformation for these two cases. As would be expected, the tangential velocity tends to extend the struck vehicle damage rearward. Front door intrusion was lower for Test No. 2 and approximately the same for the rear door (see Table 2). Acceptable structural integrity was maintained for both cases. Occupant responses presented in Table 3 indicate that the acceleration exposure of the front seat dummy was more severe in Test No. 1 (zero tangential velocity) than for Test No. 2 (50 MPH tangential velocity), whereas the opposite trend is evident for the rear seat dummy. For both cases, the front seat dummy responses were well within the assumed human tolerance limits. The lateral chest acceleration of the rear dummy was marginal for Test No. 1 and exceeded the particular injury criterion for Test No. 2.

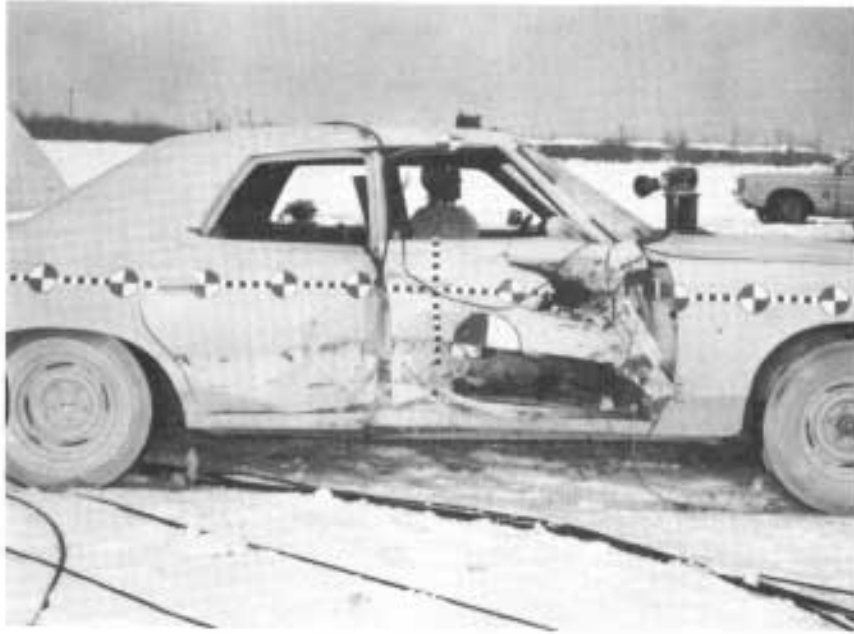
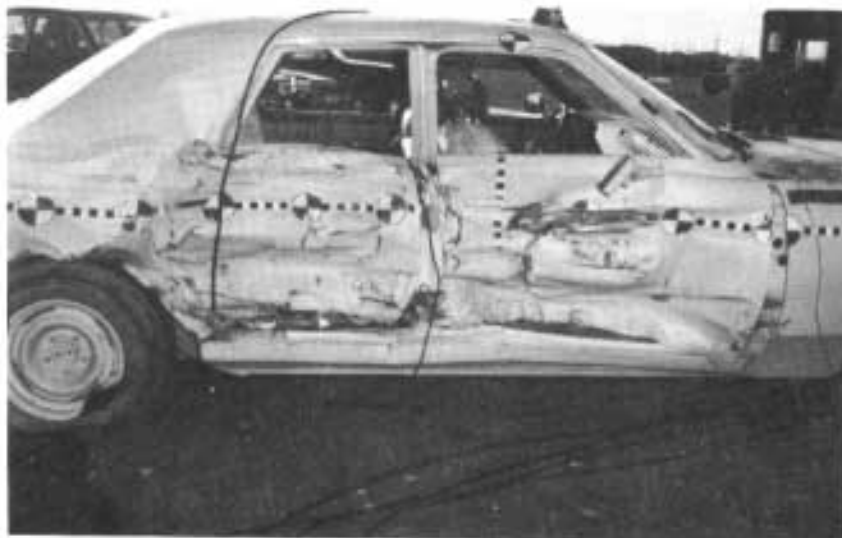
(a) ZERO TANGENTIAL VELOCITY (TEST NO. 3)

(b) 30 MPH TANGENTIAL VELOCITY (TEST NO. 4)

Figure 28 EFFECT OF TANGENTIAL VELOCITY ON VEHICLE DEFORMATION IN 30 MPH OBLIQUE COLLISIONS

Figure 28 shows that the struck vehicle deformation was mainly restricted to the initial contact area for the stationary struck vehicle case. The effect of the 50 MPH tangential velocity was to extend the damage rearward as a result of the sliding action. Structural integrity was better maintained for the latter case as evidenced by the penetration of the front fender sheet metal by the bumper and fender of the striking vehicle occurring in Test No. 3 (Figure 28a). Similar to the perpendicular impact situation, the front dummy acceleration exposure was generally more severe for the oblique case where the struck vehicle was initially stationary whereas the rear dummy

Test No. 6 corresponded to the same oblique impact configuration as Test No. 3 except that a contoured-face moving barrier was substituted for the conventional striking vehicle. Comparing Figure 30(a) and Figure 28(a), it is clear that the moving barrier resulted in a more evenly distributed loading than the conventional striking vehicle. The magnitude of impact loading was approximately double for the moving barrier case as indicated by the comparison of struck vehicle lateral acceleration levels contained in Table 2. Front dummy lateral accelerations were substantially increased for the moving barrier case, whereas the rear dummy responses were quite similar for the two cases (see Table 3).

Test No. 7 was similar to Test No. 4 except that the initial contact point on the struck vehicle was moved forward approximately 10" to determine the effect of loading the A-pillar region, which has substantially more lateral strength than the front door structure. Comparing Figures 30(b) and 28(b) indicates very little difference in overall vehicle deformation. However, intrusion of the front door structure was increased by moving the impact point forward and, conversely, the rear door intrusion was reduced somewhat (see Table 2). Correspondingly, the lateral acceleration response of the front

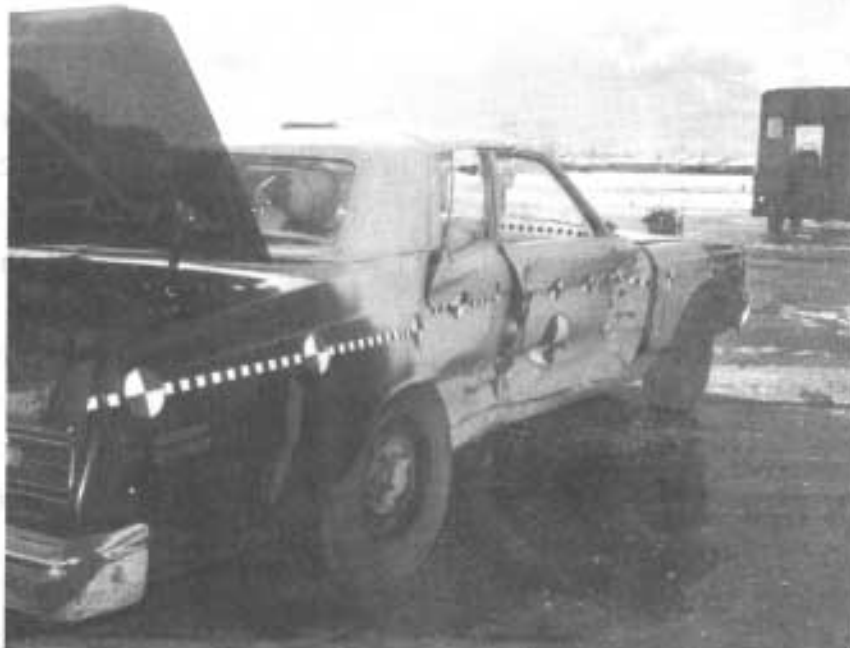
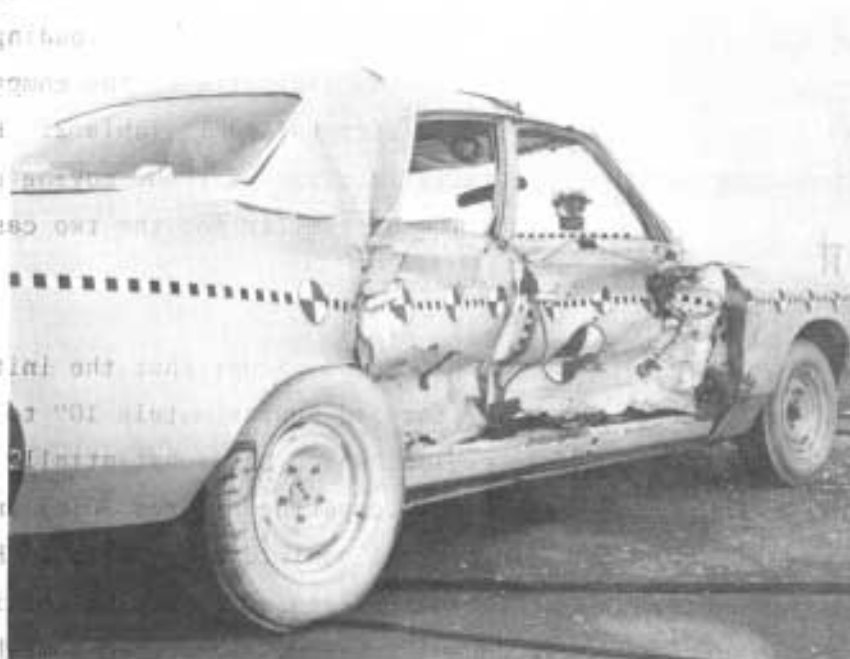
(a) TEST NO. 1 (29.7 MPH)

(b) TEST NO. 5 (37.3 MPH)

Figure 29 EFFECT OF IMPACT SPEED ON STRUCK VEHICLE DEFORMATION FOR PERPENDICULAR LATERAL COLLISIONS

Test No. 5 was similar to Test No. 1 except that the striking vehicle impact velocity was increased from 29.7 MPH to 37.3 MPH. Figure 29 compares the struck vehicle damage and indicates that the increased impact speed produced substantial override of the floorpan sill structure and sheared the B-pillar from the sill attachment point. The increase in static intrusion and average lateral acceleration of the struck vehicle is evident when referring to Table 2. Front and rear dummy lateral accelerations were significantly increased for the higher speed case to the point where the front dummy acceleration exposure appears to be marginally survivable and the rear dummy chest response clearly exceeded the assumed human tolerance limits (see Table 3).

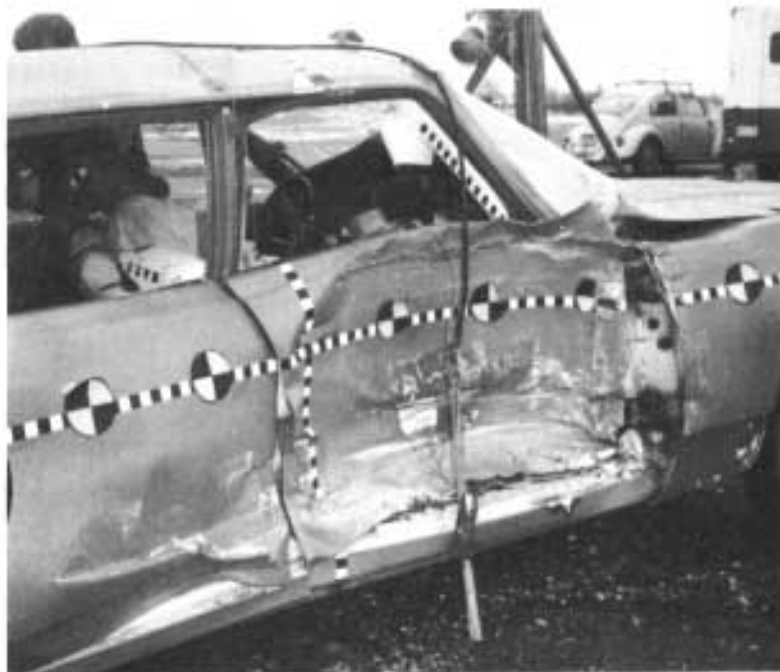
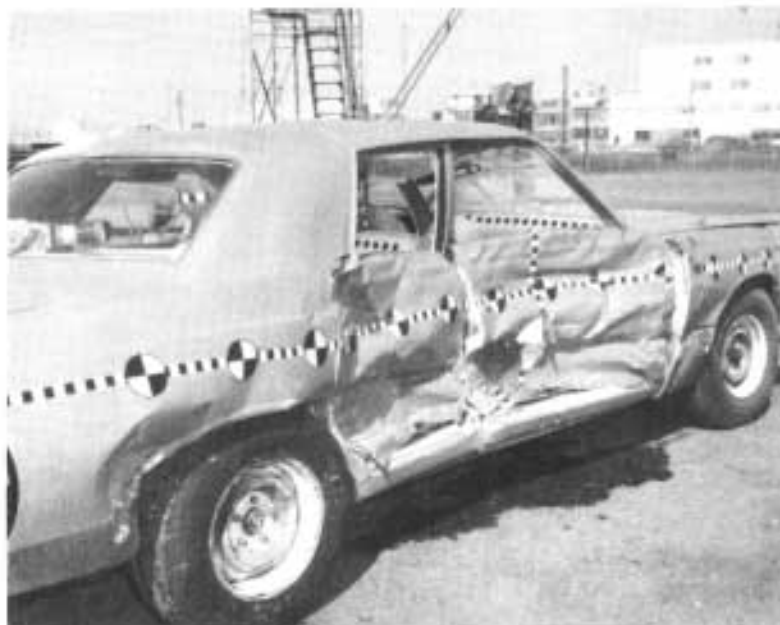
(a) TEST NO. 6 (MOVING BARRIER)

(b) TEST NO. 7 (IMPACT POINT MOVED FORWARD)

Figure 30 EFFECTS OF MOVING BARRIER IMPACT AND OF MOVING THE IMPACT POINT FORWARD

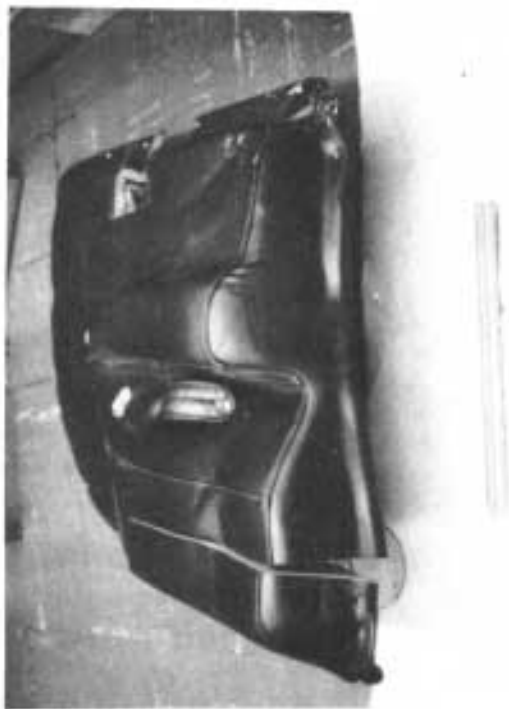
(a) PANEL WITH SECTION CUT

Figure 36 ILLUSTRATION OF DOOR PANEL HONEYCOMB CRUSH

The crushable door panel installations were shown to be quite effective in controlling occupant loading. However, further refinement of the crush strength (load-deflection) properties is needed to demonstrate further occupant protection. Figure 36 illustrates the extent of crush at the upper torso contact area that resulted for the front door panel installations corresponding to the particular crash tests. Complete crush of the upper torso contact area occurred in all cases except for Test No. 9 (complete structural and interior modifications), in which approximately 1" of uncrushed depth remained. Crush capability of the lower contact areas from lower torso and hip impact appeared to have been exhausted in all cases. Evaluation of the torso response wave-shapes and the physical crush evidence indicates that the paper honeycomb crush strength needs to be increased by about 25%. This could be accomplished by either reducing the cell sizes or impregnating the paper with phenolic resins.**

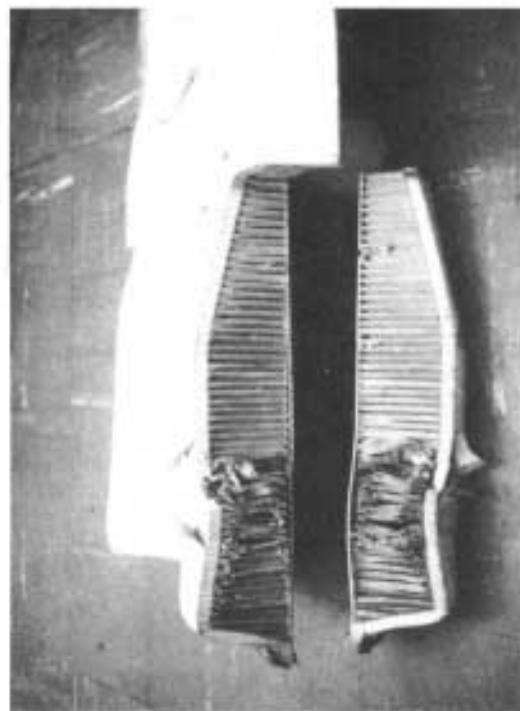
(b) TEST NO. 9

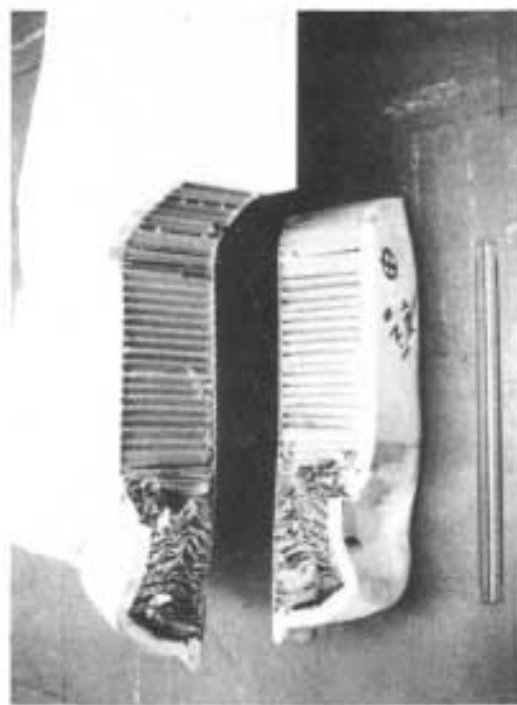
(d) TEST NO. N-1

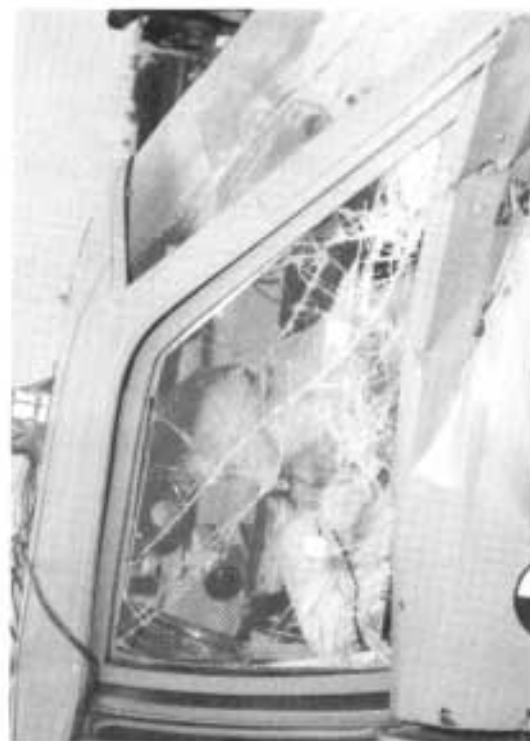
(b) TWO-PLY ANNEALED (TEST 10)

Figure 37 EXAMPLES OF LAMINATED GLAZING FRACTURE

With respect to the laminated glazing installations in the modified vehicles, there was no indication of significant head contact resulting from the lateral impact tests. Consequently, although the peripherally supported glazing provided an energy-absorbing containment surface as shown in Figure 37, no such additional protection appeared to be needed, at least for the particular impact conditions considered. Fracture of the glass plies evident in Figure 37 was caused by the structural impact response in all cases and not by dummy contact. Such a containment surface would more likely be of benefit in rollover accident types, particularly if occupants are unrestrained. The need for protective side glazing could also be more apparent in other lateral impact modes and/or for automobiles of smaller size (see Ref. 4). Finally, the degree of anthropomorphic dummy lateral response fidelity has an important bearing on this subject.*

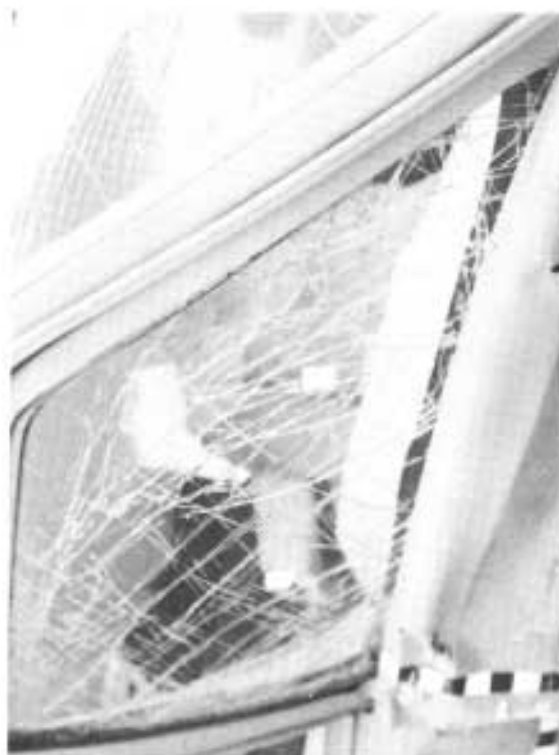
(c) TWO-PLY ANNEALED (TEST N-1)

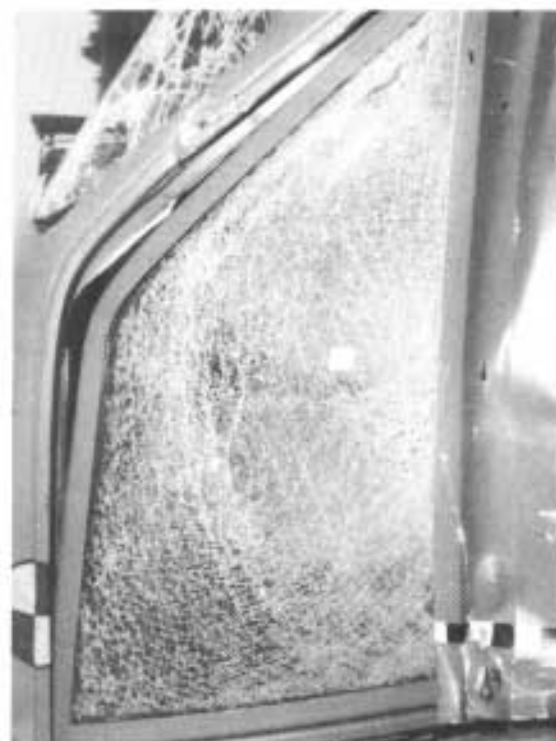
(d) BILAYER (TEST 12)
